# Cabinet Floor Repair

## SERVICE COMPLETION REPORT AND PHOTO RECORD

| <b>PROPERTY</b> | | <b>JOB REFERENCE</b> | ANC-2026-0806-01 |
| <b>LOCATION</b> | Utility room, sink base cabinet | <b>PERFORMED BY</b> | Anchor Property Services Company |

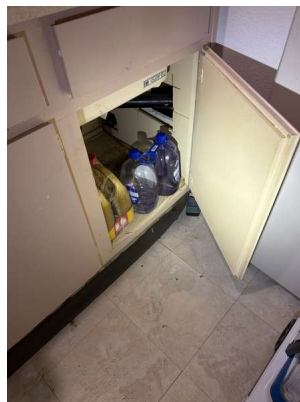
**PHOTO 2** 9:21 AM

Cabinet interior before work. Stored contents sitting directly on the damaged floor.

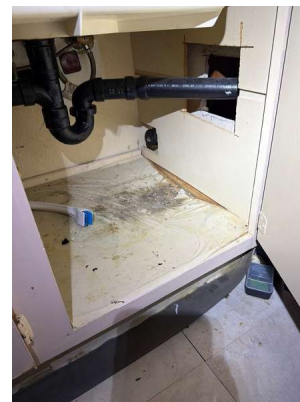
**PHOTO 3** 9:22 AM

On arrival the sink base cabinet floor was water damaged across a broad area, with swelling, surface staining, and loss of integrity concentrated at the rear of the cabinet adjacent to the drain line. Stored contents were sitting directly on the damaged surface. See photos 1 through 7.

Starting condition of the cabinet floor. Water staining, swelling, and surface debris.

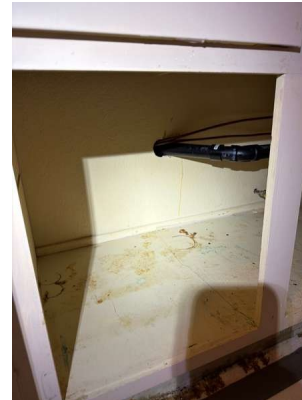
**PHOTO 6** 9:49 AM

Cabinet interior cleared, showing the extent of staining across the floor panel.

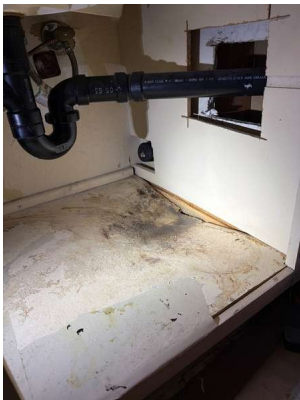
**PHOTO 7** 9:49 AM

Failed section at the rear of the cabinet, adjacent to the drain line.

- This was a partial repair. The original particle board floor remains in place outside the 24 by 13 inch replaced section. That material has prior water exposure and may continue to deteriorate.
- Full replacement of the cabinet floor can be quoted separately if you would like it addressed.

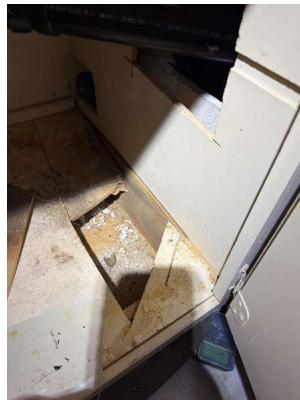
**PHOTO 8** 9:56 AM

Once the failed section was cut and lifted, two separate rodent nesting sites were exposed in the void beneath the cabinet floor. A deceased rodent was present at the second site. This condition was not visible before the panel was opened and could not have been identified from the surface. See photos 8, 9, and 10.

Rodent nesting material found beneath the floor panel at the first cut.

- Two nesting sites and a deceased rodent indicate established activity, not a single incident. We recommend an inspection by a licensed pest control operator to locate the full entry path and check for additional nesting elsewhere in the structure.
- Expanding foam closes the gap and stops airflow, but rodents can chew through it over time. A durable seal packs the void with copper mesh or stainless steel wool before foaming. We recommend this be done at the sealed locations.
- The cavity was vacuumed out but was not sanitized or treated. It is now covered by the new panel. We recommend sanitizing be addressed by the pest control operator at the time of inspection.
- We recommend the stored contents that were sitting in the cabinet be wiped down before continued use.

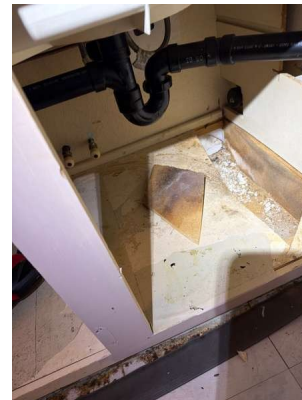
**PHOTO 9** 9:57 AM

Second nesting site identified beneath the panel, with a deceased rodent present.

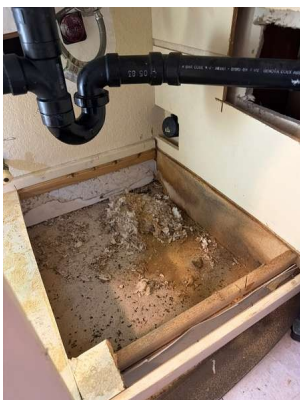
**PHOTO 10** 10:02 AM

Void beneath the removed section fully exposed, showing accumulated nesting material and debris.

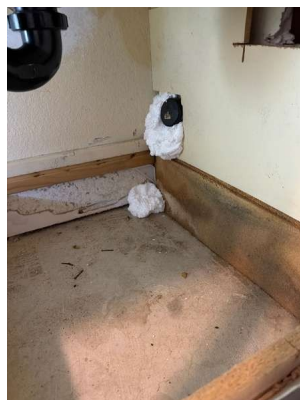
**PHOTO 11** 12:04 PM

Rodent entry points identified at the wall and pipe penetration, sealed with expanding foam.

6. Rodent entry points at the wall and pipe penetration sealed with expanding foam.
7. A 1x2 support cleat was installed to carry the new panel at the cut edge.

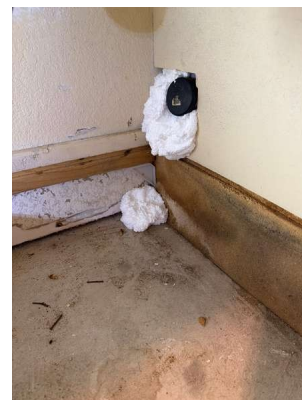
**PHOTO 12** 12:05 PM

Sealed entry points after the cavity was vacuumed and cleared.

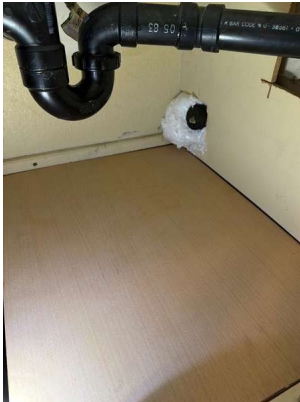
**PHOTO 13** 1:32 PM

New plywood section installed on a 1x2 support cleat, set flush to the surrounding floor.

8. A new plywood section was cut to fit, installed on the cleat, and set flush with the surrounding cabinet floor.
9. A protective liner was installed across the cabinet base using rubber sheet material supplied by the client.

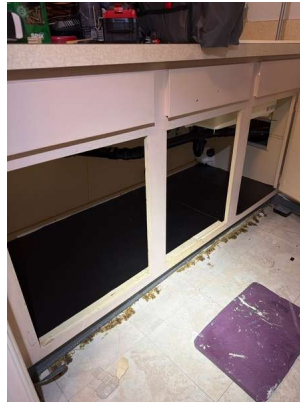
**PHOTO 14** 1:49 PM

Protective liner installed across the cabinet base using client supplied rubber sheet.

- The rubber sheet installed across the cabinet base is a temporary protective barrier using material you already had on hand. It is not a sealed or finished waterproof surface and is not warranted as one. A finished, sealed cabinet floor surface can be quoted separately.

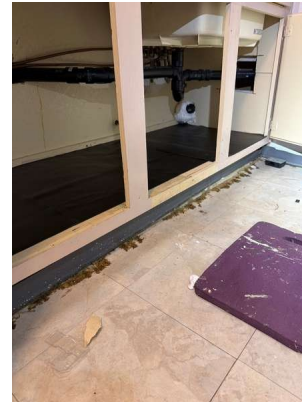
**PHOTO 15** 1:49 PM

Baseboard reattached at the cabinet toe kick.
