RESIDENTIAL SERVICE REPORT

# Dryer Vent Cleaning and Airflow Verification

San Marcos Residence

| REPORT NUMBER | ANC-DV-20260807-01 | SERVICE DATE | Friday, August 7, 2026 |

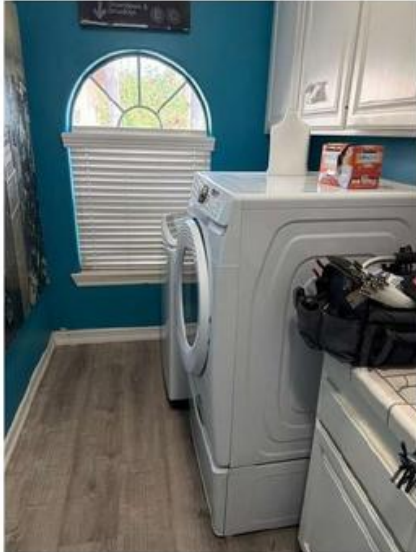
01 8:59 AM

Arrival. Laundry area documented before any work began, appliance staged forward for access.

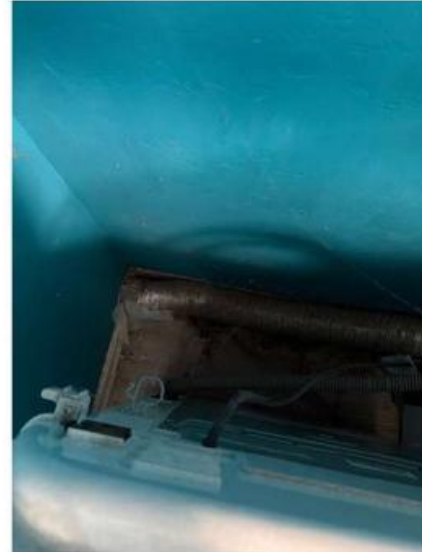
02 8:59 AM

- The transition duct behind the appliance is in serviceable condition, but it is compressed between the dryer and the wall with a tight bend at the connection.
- The transition enters a recessed wall cavity. Lint carryover and surface staining were present inside the recess, consistent with a long service interval and moisture that could not clear the run.
- Baseline airflow and the elevated discharge temperature both indicated significant restriction before cleaning.
- No damage to the duct run, the appliance connection, or the wall was observed during the visit. No parts required replacement.

Starting condition. Recessed wall cavity behind the dryer with the transition duct seated inside the recess. Lint carryover and surface staining visible in the recess.

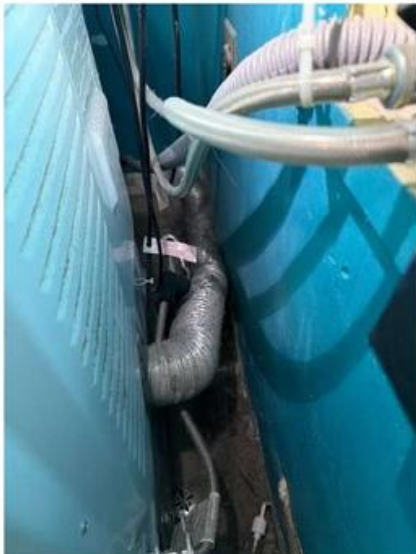
03 9:00 AM

The transition duct itself is sound and was cleaned and reinstalled rather than replaced. The issue is clearance. The dryer sits close enough to the wall that the duct is compressed into a tight bend at the connection, and on a four foot run with no elbows that single crushed bend is the one place lint has to catch.

Starting condition. Transition duct compressed between the appliance and the wall, with tight bends at the connection.

- › Fit a periscope or a rigid elbow at the appliance outlet so the dryer can sit close to the wall without crushing the duct.
- › When the appliance is pushed back after any service, check that the transition still holds an open radius rather than folding against the wall.

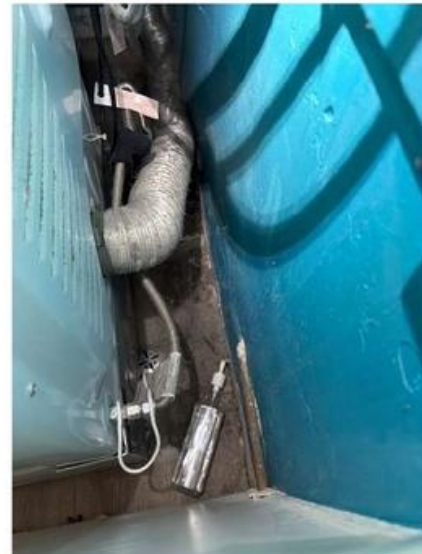
04 9:00 AM

Starting condition. Close view of the transition connection and the utility connections at the wall recess.

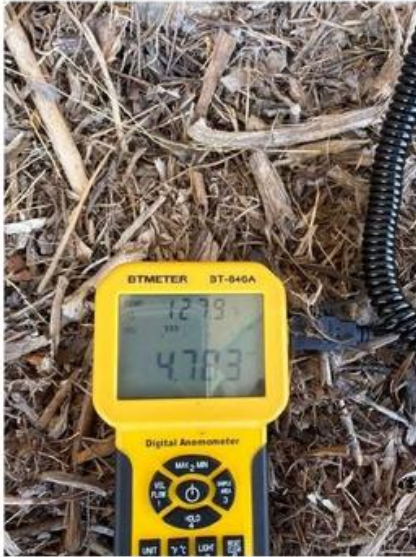
05 9:11 AM

Baseline exhaust velocity measured 470.3 FPM with a discharge temperature of 127.9 F, which is consistent with a heavily restricted run. After cleaning, velocity measured 821.2 FPM with a discharge temperature of 109.6 F. Both readings were taken at the same point with the dryer running under the same settings, so the two numbers are directly comparable.

Baseline airflow reading at the exterior termination with the dryer running. 470.3 FPM, discharge temperature 127.9 F.

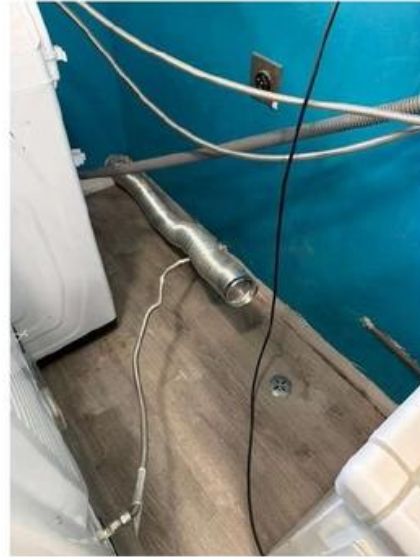
06 9:26 AM

Run cleaned end to end. Transition duct cleaned and staged for reconnection.

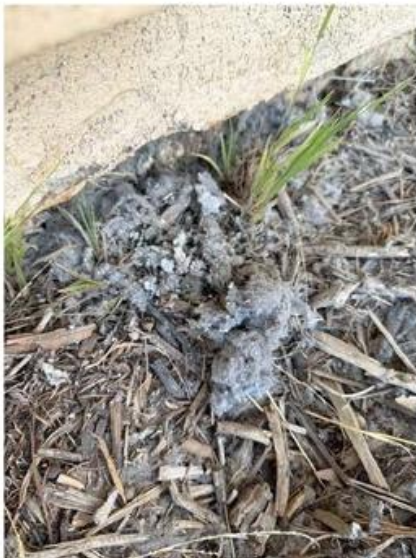
07 9:26 AM

The run measures roughly four feet with no elbows, which makes the baseline number worth pausing on. A run this short and this straight should move air freely. It did not, and the volume of lint recovered at the termination (Photo 07) shows why. Interval, not layout, is what put this system where it was.

Lint recovered at the exterior termination after the run was brushed through. Material of this volume on a four foot run indicates a long interval since the last cleaning. Collected and removed from the site.

- › Clear the lint screen before every load and never run the dryer without it in place.
- › Watch cycle times. When loads that used to finish in one cycle start needing two, the run is loading up again.
- › Schedule the next cleaning at twelve months, or sooner if drying times lengthen or the exterior outlet shows lint at the hood.

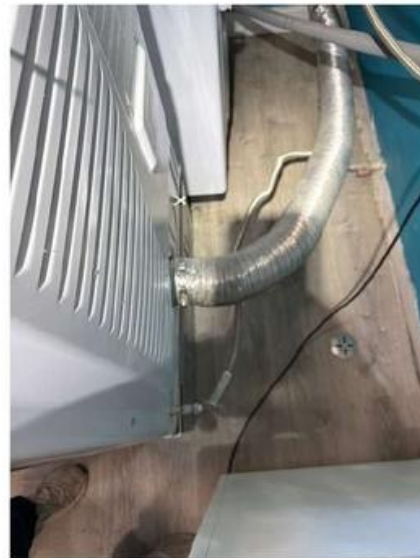
08 9:29 AM

Transition duct reconnected and clamped at the appliance outlet.

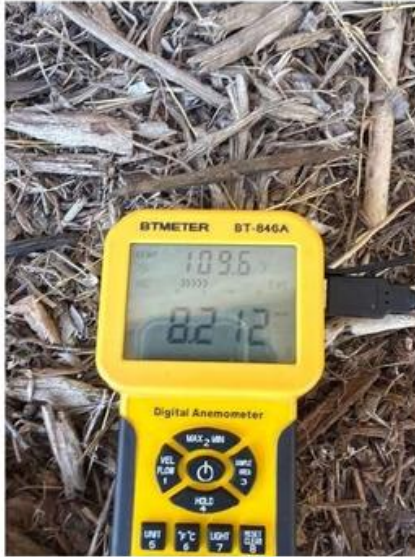
09 9:33 AM

Verification airflow reading at the exterior termination under the same test conditions. 821.2 FPM, discharge temperature 109.6 F.

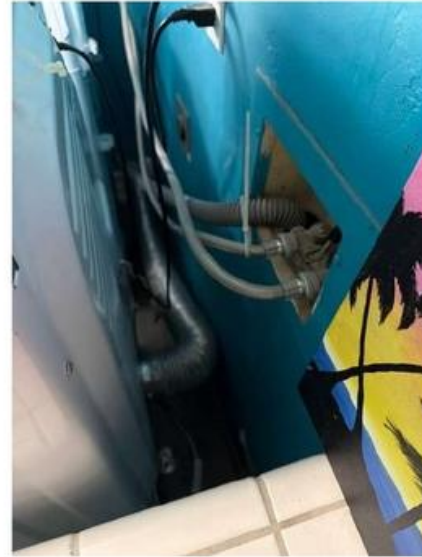
10 9:40 AM

Appliance returned to position, connections checked, work area cleared. System returned to service.
