## RESIDENTIAL SERVICE REPORT

# Dryer Vent Cleaning and Roof Jack Service

## North County Residence

| REPORT NUMBER | ANC-DV-20260817-01 | SERVICE DATES | August 17 and August 19, 2026 |

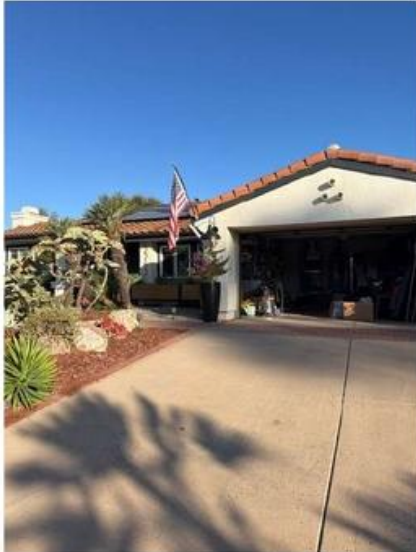
01 Aug 17, 7:37 AM

Arrival. Single story tile roof residence documented before any work began.

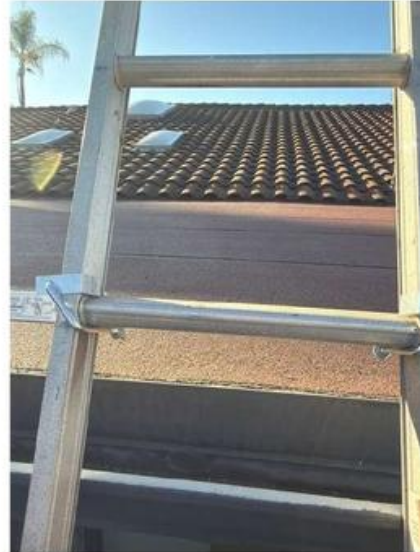
02 Aug 17, 7:40 AM

Ladder staged at the eave with a stand-off so the ladder bears on the fascia and not on the tile or the gutter.

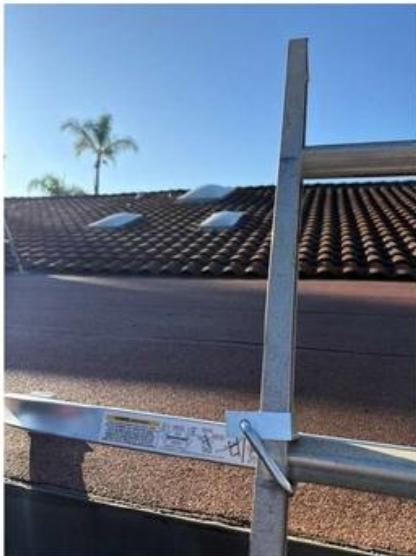
03 Aug 17, 7:40 AM

Ladder set and footed on level ground before roof access.

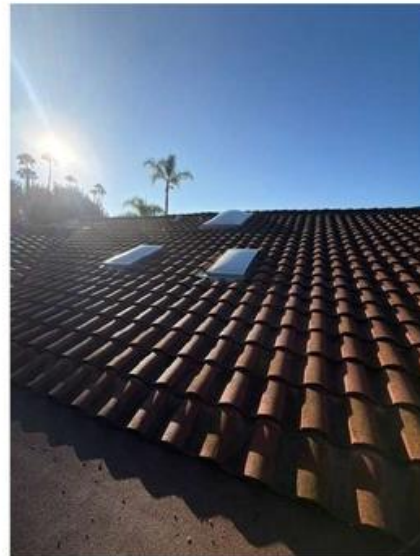
04 Aug 17, 7:40 AM

- The run measures approximately eight feet and terminates through a jack on the first story tile roof.
- Roof tile in the work area was assessed on a pre-walk before any weight was placed on the roof. No cracked, slipped, or broken tile was observed in the access path or at the jack, and none was created during the work.

Roof pre-walk. Tile field and pitch assessed and photographed before any weight was placed on the roof.

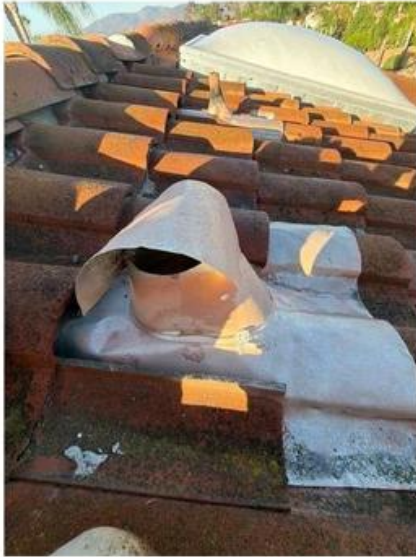
05 Aug 17, 7:44 AM

- The duct throat behind the cap was packed solid with compacted lint on arrival.
- The roof jack cap was deformed open and its securing rivet was absent. The cap was loose on the collar and could be lifted by hand.

| Observation | On arrival | At completion | Evidence |
|---|---|---|---|
| Cap condition | Deformed open, rivet absent | Seated and re-riveted | Photos 05, 13, 14 |

Vent located. The cap was found deformed open and the securing rivet was absent, leaving the cap loose on the collar.

The amount of compacted material removed from this run indicates the previous interval was far too long. The cap has now been re-secured with a new rivet, but a cap that has already deformed once and lost its fastener is a component worth checking rather than assuming.

- › Set the next cleaning at twelve months and treat that date as firm rather than as needed.
- › Check the cap seating and the rivet at every service visit while on the roof.
- › Watch drying times between visits. Loads needing two cycles is the early signal the run is loading again.

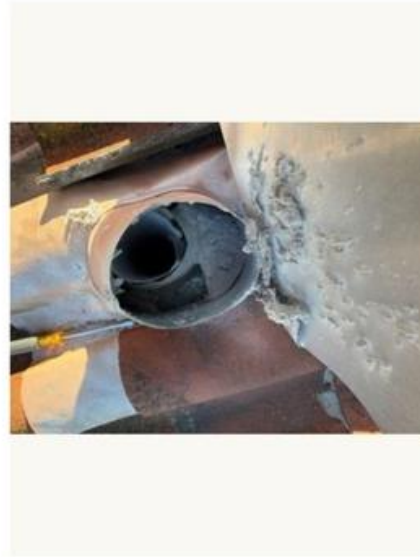
06 Aug 17, 7:45 AM

On arrival the cap was found deformed open with its securing rivet absent, and the duct throat behind it was packed solid with compacted lint (Photo 06). A dryer exhausting into a duct in this condition recirculates heat and moisture into the appliance and the cabinet, which is the condition most commonly associated with dryer fires.

| Observation | On arrival | At completion | Evidence |
|---|---|---|---|
| Duct interior at the throat | Packed solid with compacted lint | Brushed clear to bare metal | Photos 06, 09 |

Starting condition at the throat. The duct is packed solid with compacted lint.

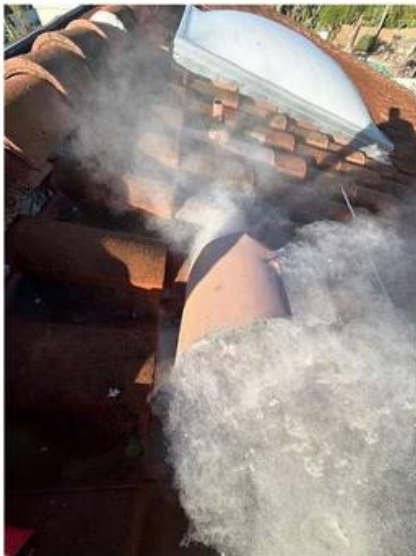
07 Aug 17, 7:51 AM

| Observation | On arrival | At completion | Evidence |
|---|---|---|---|
| Lint discharged during cleaning | Not applicable | Heavy, expelled at the jack | Photos 07, 08 |

Cleaning in progress. Lint discharging from the jack as the run was brushed through with the dryer running.

The run was brushed through from the roof with a drill driven brush while the dryer ran, which carried the loosened material out through the jack (Photos 07 and 08). The throat was cleared to bare metal (Photo 09) before the crew left the roof.

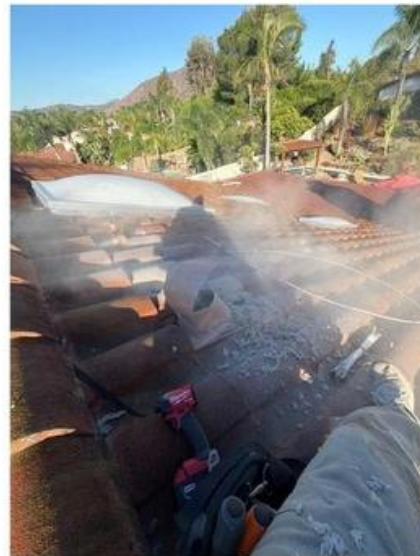
08 Aug 17, 7:51 AM

Wider view of the discharge. Volume of this kind indicates a long interval since the last cleaning.

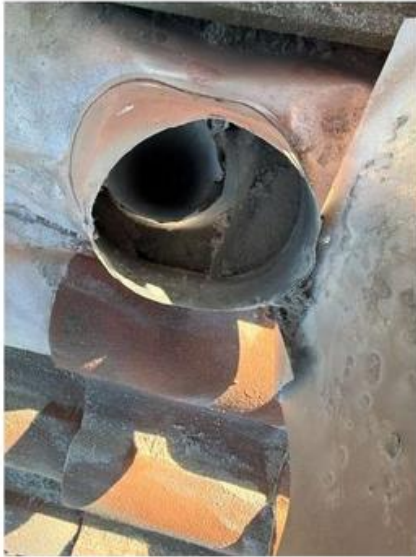
09 Aug 17, 7:55 AM

Throat cleared to bare metal. Compare directly against Photo 06.

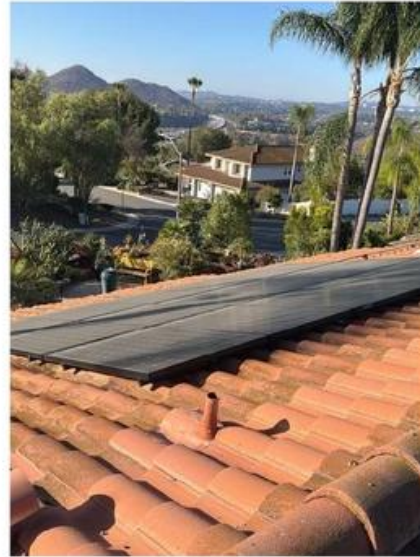
10 Aug 17, 7:58 AM

- A roof mounted solar array is present on the adjacent slope. Documented for reference only.

Roof mounted solar array observed and photographed from the work position. Documented for reference only, no work performed.

- › Solar panel cleaning, quoted per property after a roof access assessment.
- › Exterior window cleaning, quoted after a walk of the glass count.
- › Anchor will follow up when the construction is expected to be complete.

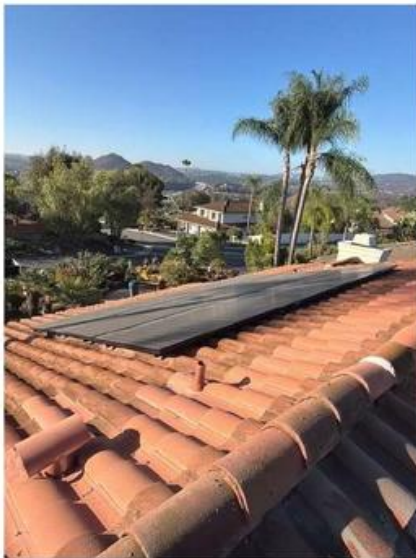
11 Aug 17, 7:58 AM

Second view of the array and the surrounding tile field.

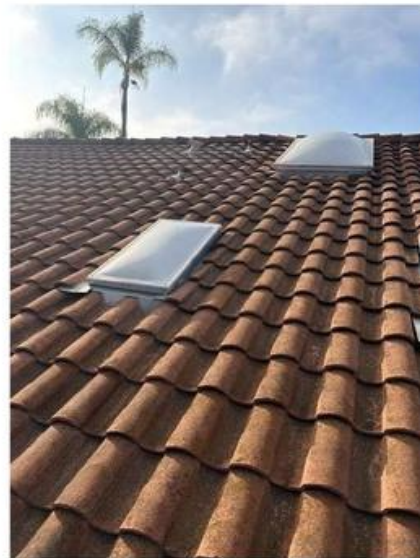
12 Aug 19, 7:55 AM

Return visit. Roof re-accessed and conditions confirmed unchanged since the cleaning.

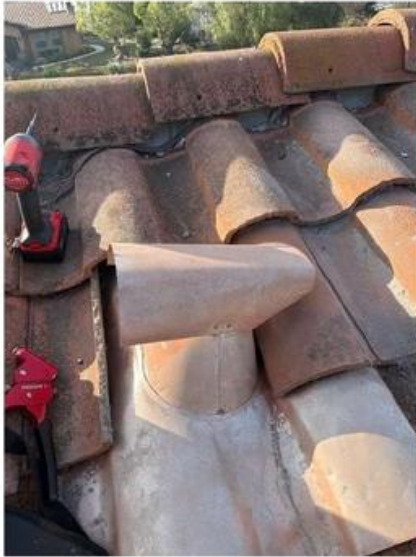
13 Aug 19, 7:58 AM

Cap seated closed on the collar and a new rivet set. The original cap was retained and re-secured. No components were replaced.

On the return visit the cap was seated closed on the collar and a new rivet was set. The original cap was retained. No components were replaced and no other work was performed.

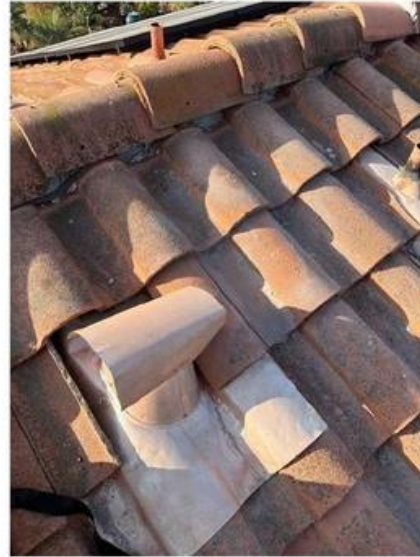
14 Aug 19, 8:01 AM

Completed. Cap closed and secured, flashing undisturbed, tools removed and the roof left clear.
