**INVOICE NO.**  
**ANC-2608-1401**

Rooftop photovoltaic array, tile  
roof

**Solar Panel Cleaning**

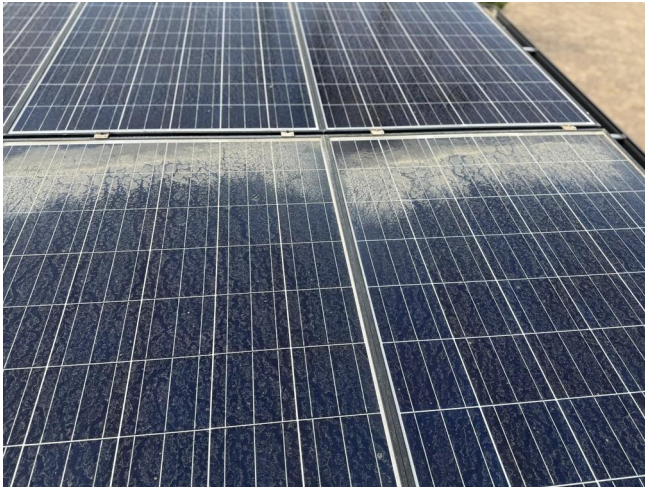
#### BEFORE

The system was carrying a heavy soil band along the lower edge of the modules and organic staining at the upper edges. Both were removed. No cracked glass, delamination, or heat damage was found on any module.

Lower module edge on the main array. Heavy soil banding and organic staining across the cell rows.

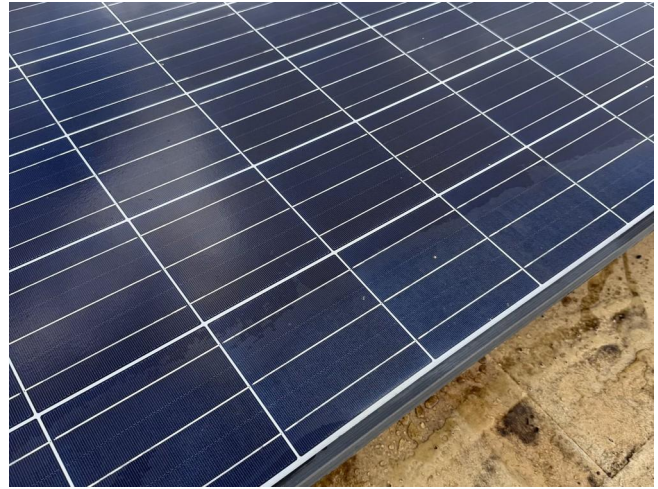
#### AFTER

Same plane after the wash and rinse. Cell rows fully exposed to light.

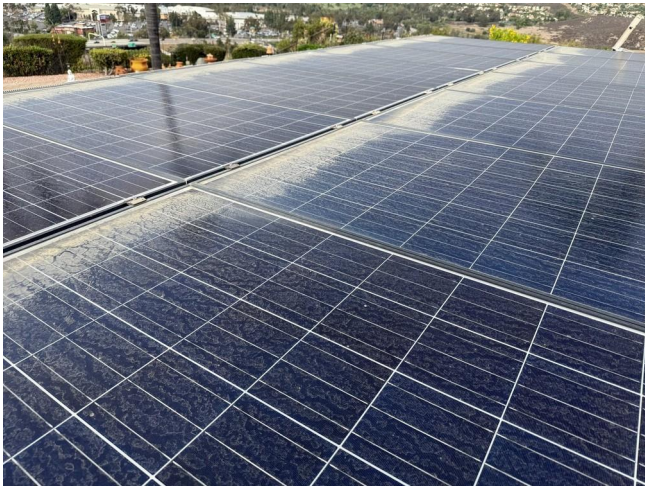
#### BEFORE

Main array looking down the slope. Dust film and dried runoff visible across the full face.

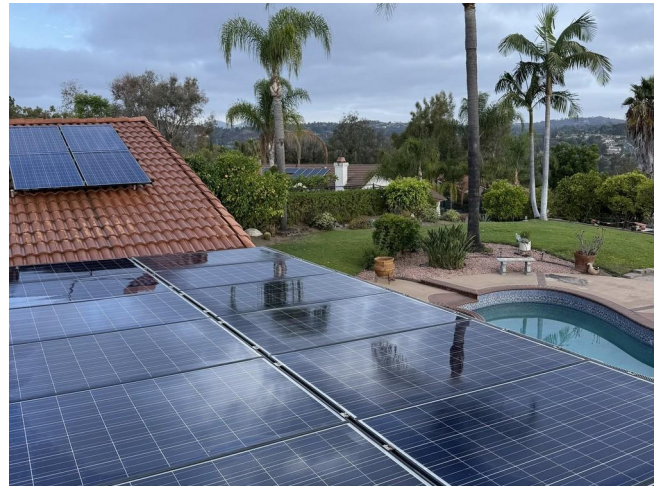
#### AFTER

Main array after service. Glass sheeting evenly with no streaking across the face.

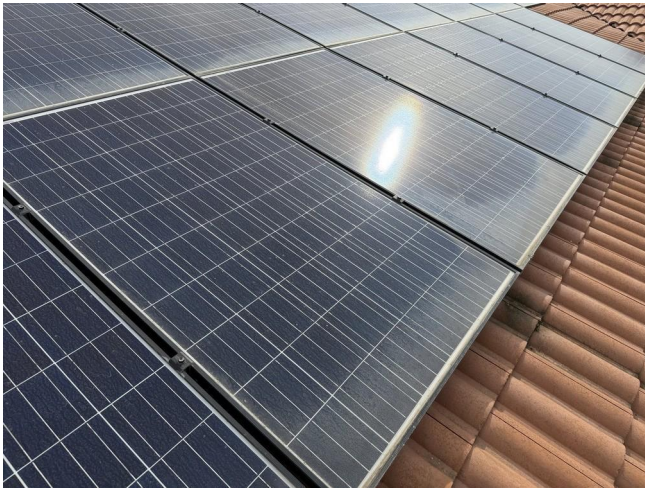
#### BEFORE

Upper roof plane on arrival. Uniform soil film with heavier accumulation toward the module frames.

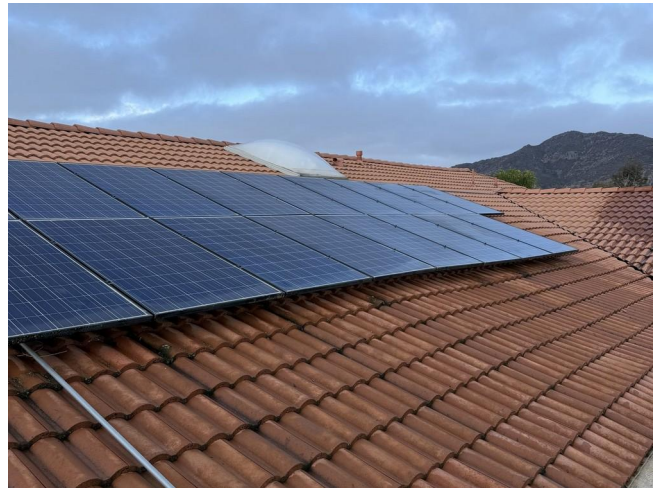
#### AFTER

Upper roof plane after service. Frame edges cleared so water sheets off rather than damming.

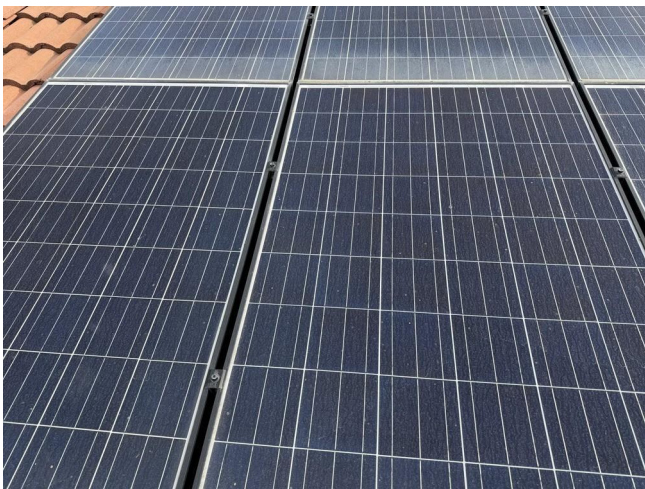
#### BEFORE

Close detail of soil accumulation between cell rows before any water was introduced.

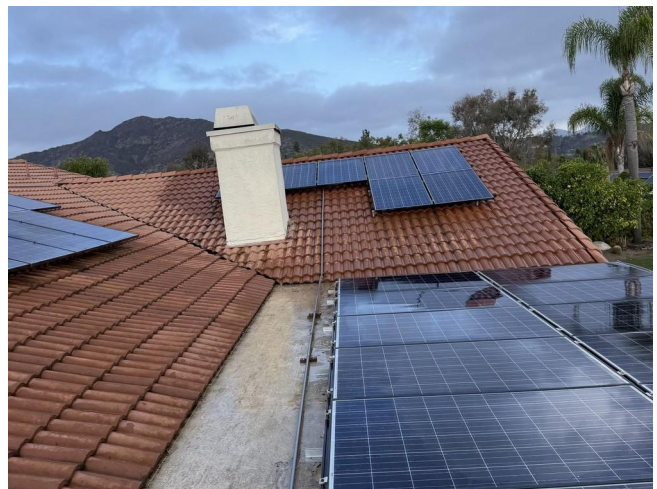
#### AFTER

Completed system across both roof planes at close of service.

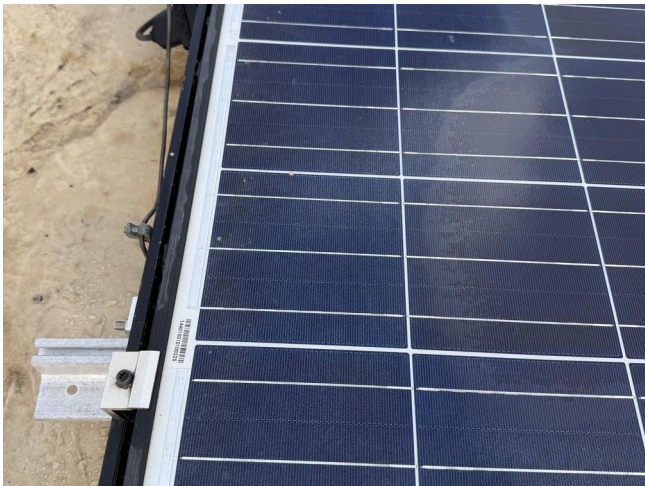
#### CLOSING INSPECTION

Module frame and mounting hardware inspected at close of service.

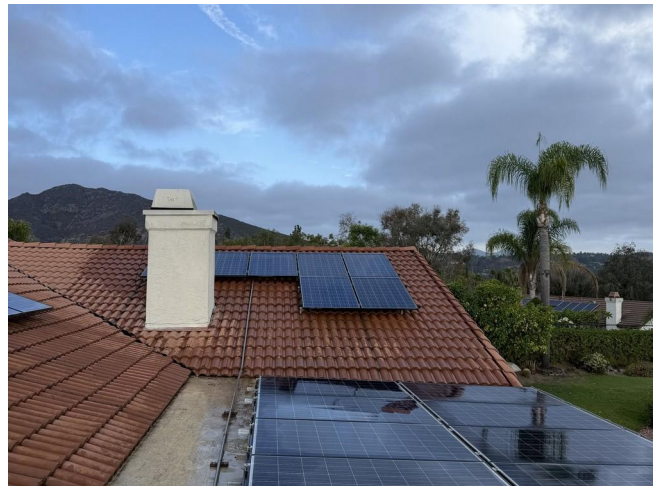
#### CLOSING INSPECTION

Completed array and roof left as found at end of visit.
